A MULTIDISCIPLINARY ENGINEERING  
GEOLOGICAL INVESTIGATION OF CLIFF  
COLLAPSE AT REDCLIFFS IN THE  
22 FEBRUARY AND 13 JUNE 2011  
EARTHQUAKES

A thesis

**Master of Science in Engineering Geology**

2013

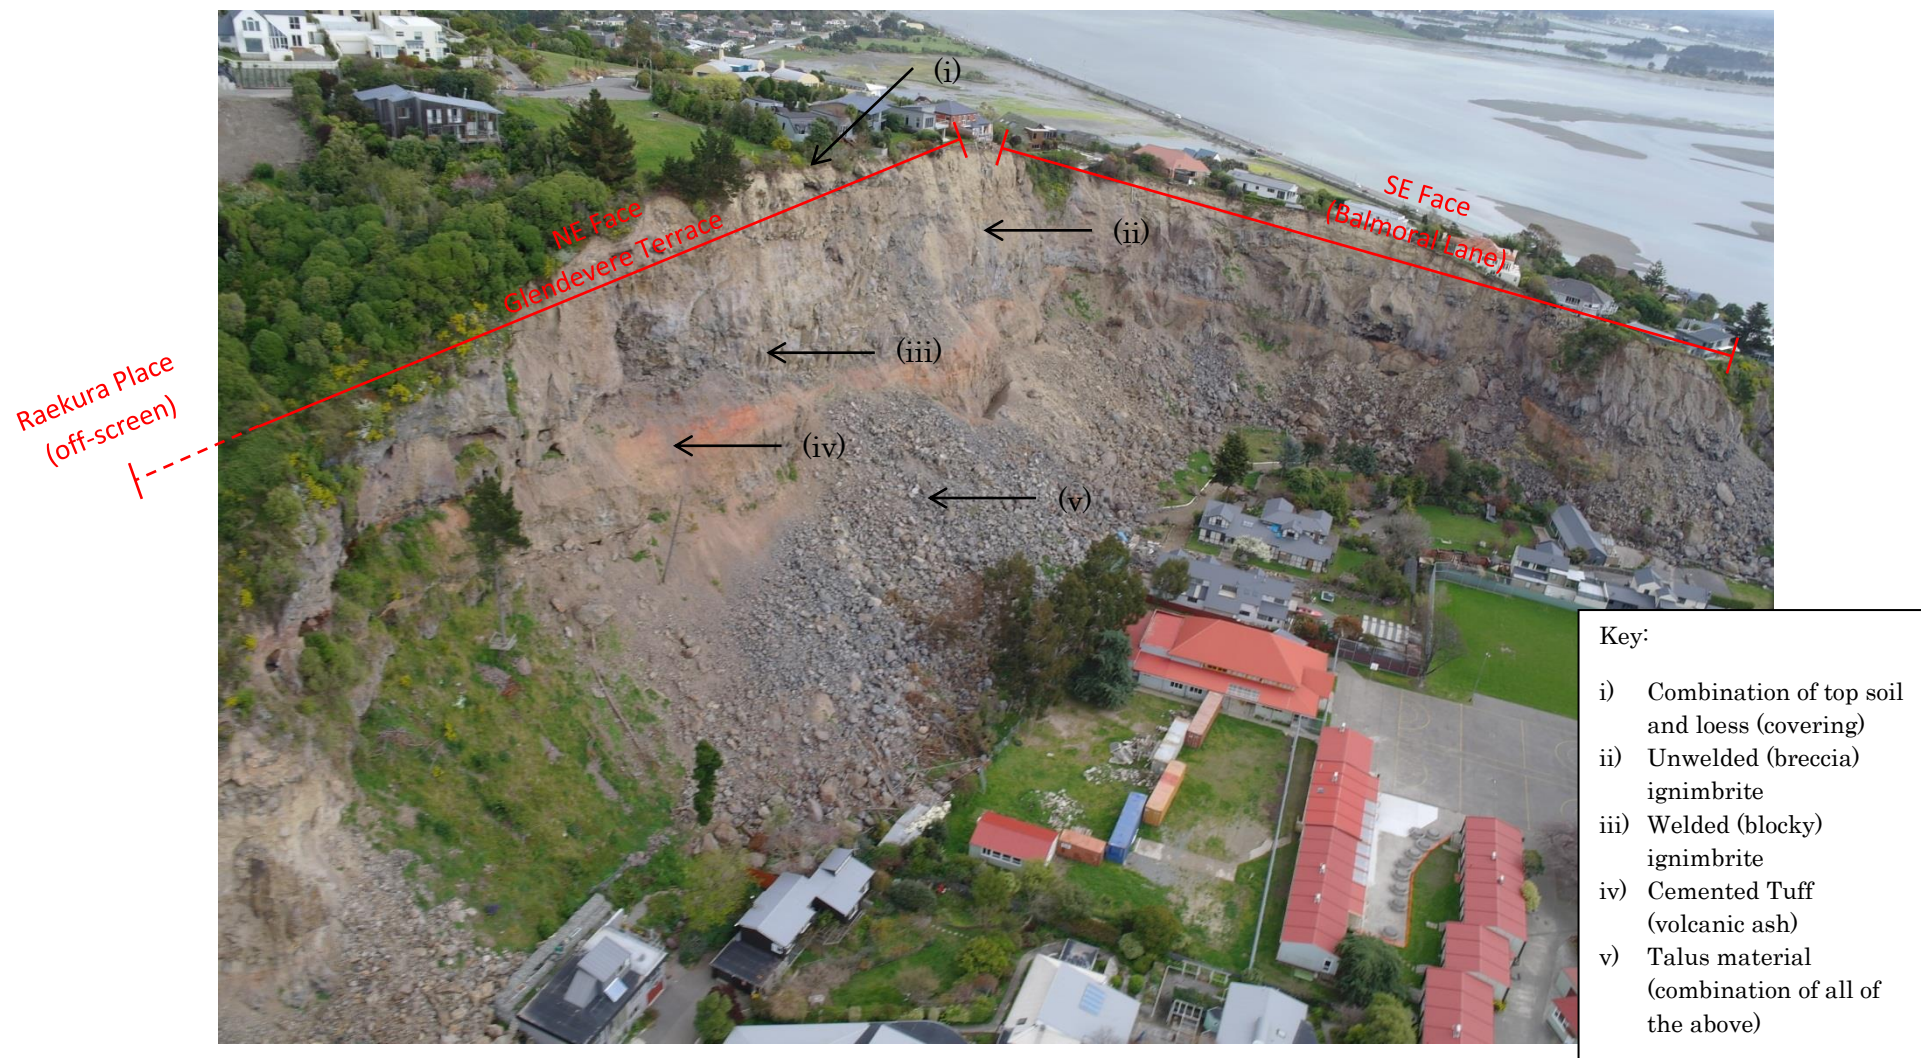
Figure 16 – Annotated photograph of Redcliffs' cliff (courtesy of Rob Hunter from Tonkin & Taylor) highlighting the boundaries of each individual units mapped on the freshly exposed cliff face and the allocated NE and SE Face labels for the two sections of the cliff facing perpendicular to each other.

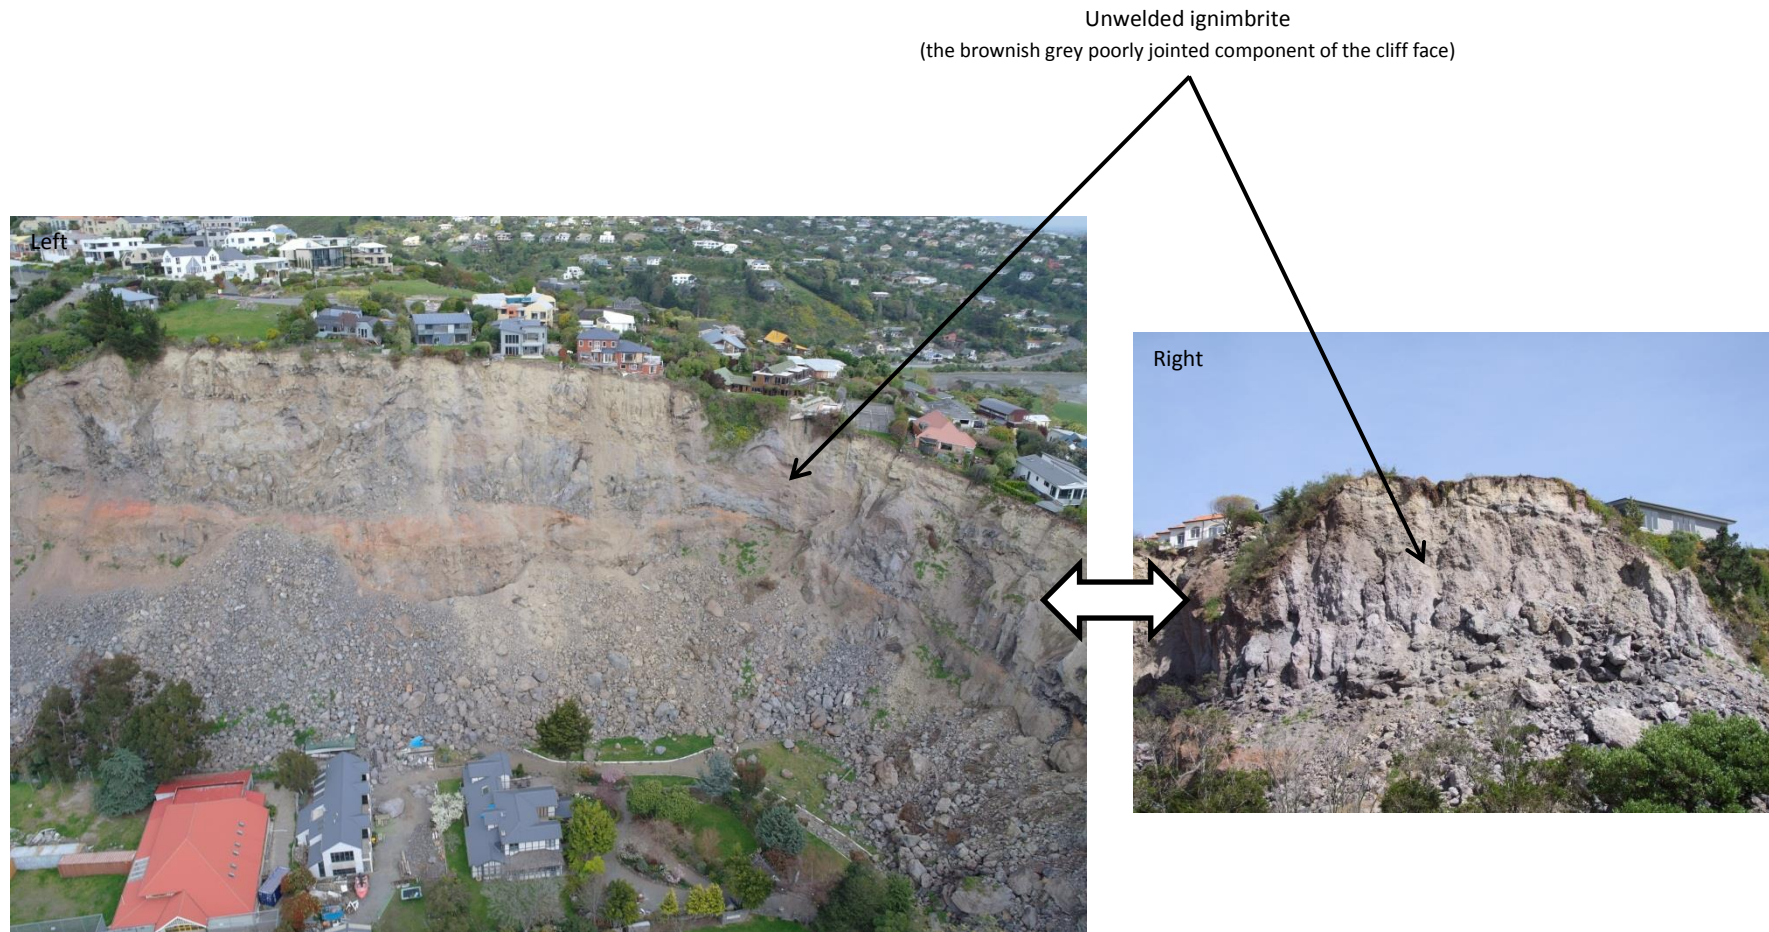
Figure 23 - A comparison between a majority of the cliff face and the far eastern tip in terms of the structure and condition of the unwelded ignimbrite. For the majority of the cliff face (left), the unwelded ignimbrite appears to be lacking in jointing, whereas the eastern tip (right) appears to have a large number of what seems to be exfoliation joints defining tabular-like blocks within the slope.

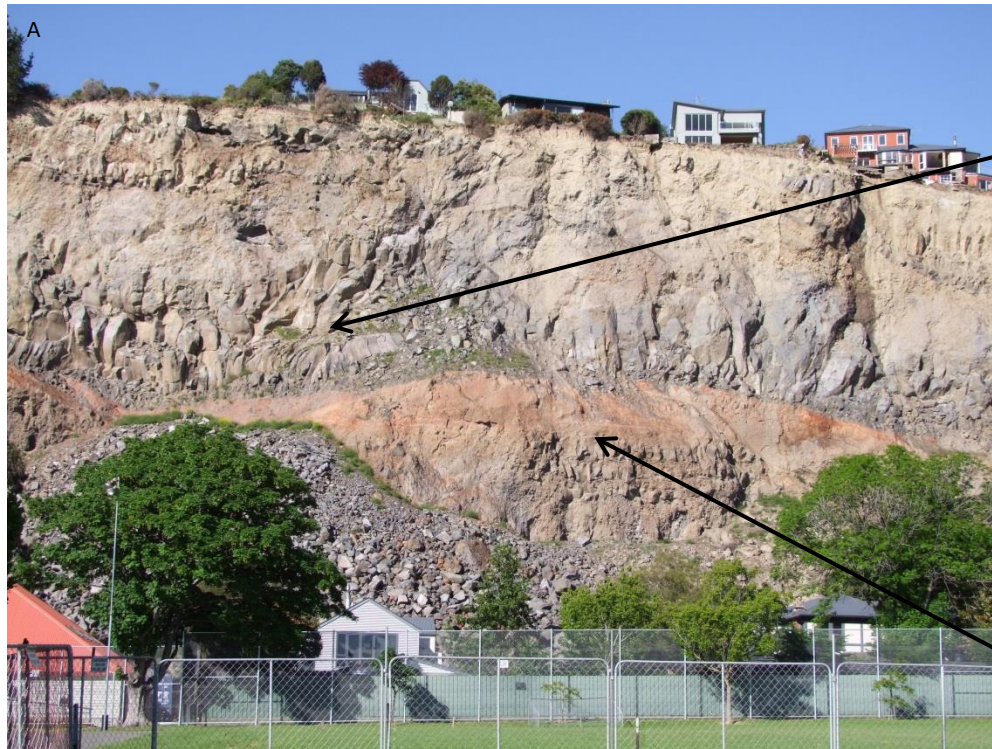
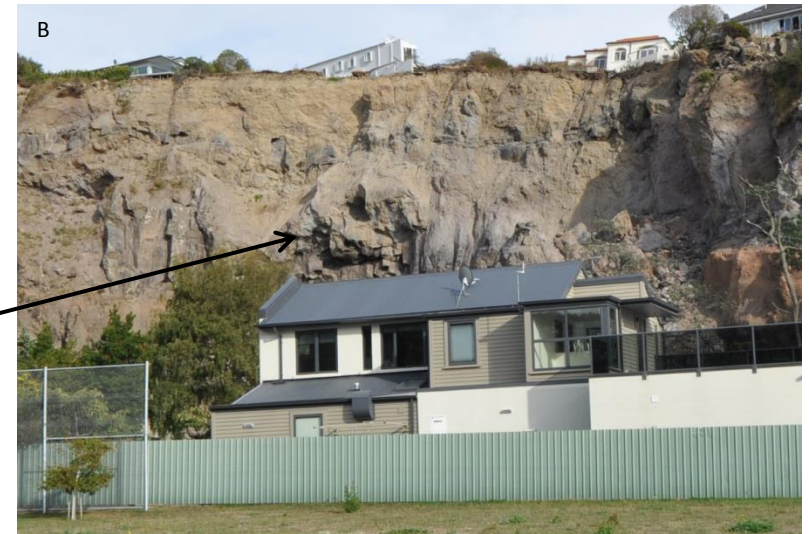
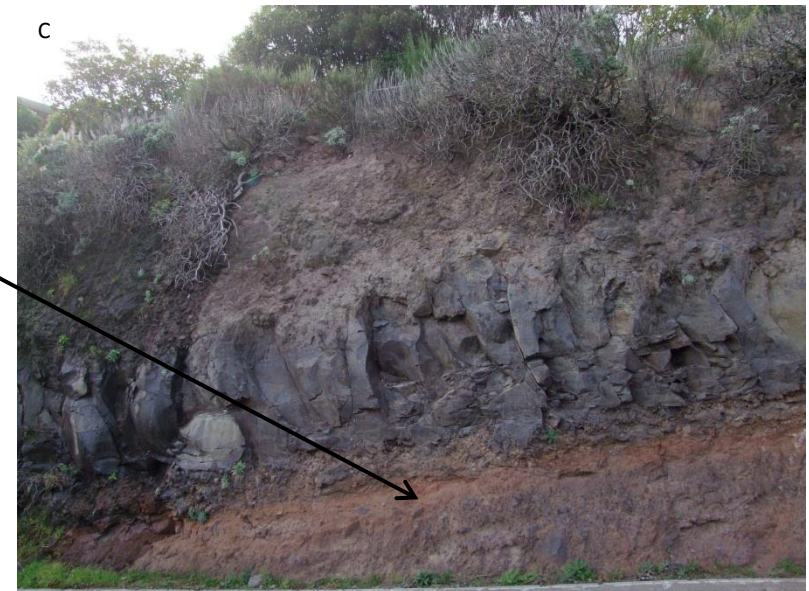
Structural changes are also evident for the welded ignimbrite, but not as severe as the unwelded ignimbrite. Comparing the NE and SE Faces, not including the small lensoidal bodies, the persistence of the joints on the NE Face are shorter than those on the SE Face, thus making smaller blocks. In contrast, the joints on the NE Face are less rounded and not as sharp, thus making the blocks appear to have “straighter” edge(s), if joints are prominent enough, and are thus more columnar-shaped (Figure 24). The only unit that did not exhibit an inconsistent structure and/or condition of the rock mass is the unit of tuff breccia as it appears to maintain a predominantly intact – blocky structure with a poor to good surface condition. However, it should be noted that there is a difference between what was observed on the cliff face and on the proxy-site; whereby the proxy-site outcrop appears to be more brecciated with more prominent evidence of large subangular blocks of broken lava embedded within the tuff matrix (Figure 24).

Figure 24 - Photographs taken of particular sections of the NE and SE face, and proxy-site comparing the difference between the structure and/or surface condition of the respective rock units. The main difference of the welded ignimbrite is the sharpness and persistence of the joints, whereby the NE Face (A) exhibits short but sharp edged joints; whereas the SE Face (B) shows “straighter” but longer persistent joints. Moreover, the difference of the tuff is between the cliff face and proxy-site, where the tuff at the proxy-site (C) appears to contain more distinct broken blocks of lava than compared to the observed unit of tuff on the cliff face.

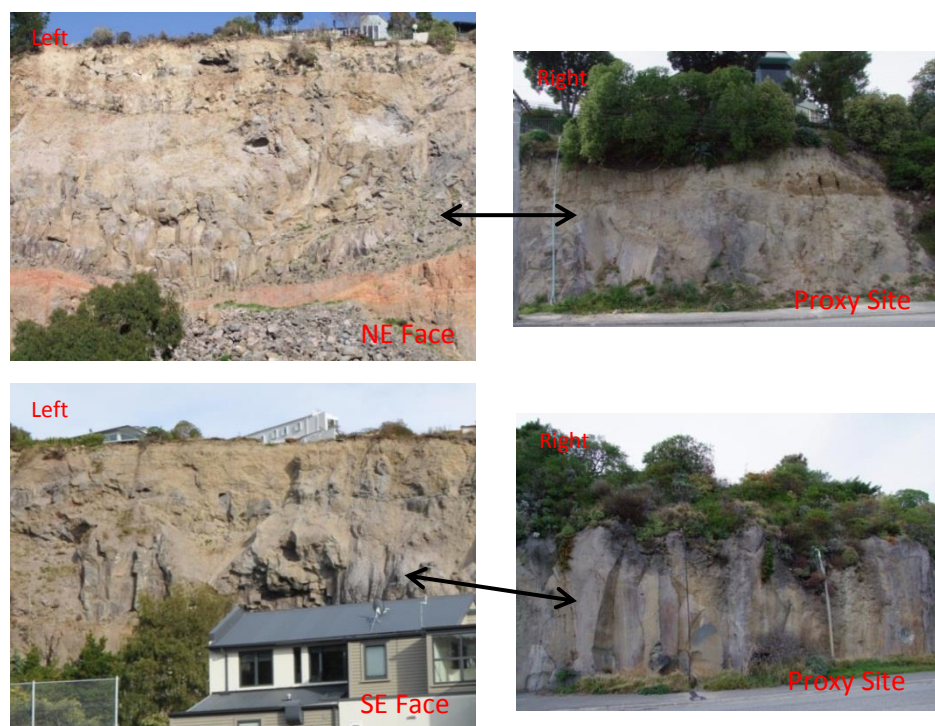
Figure 25 - Photographs comparing between the jointed blocks of welded ignimbrite on the cliff face (left) and the proxy-site outcrops (right) of the same unit chosen to represent the cliff to conduct a Schmidt Hammer test.

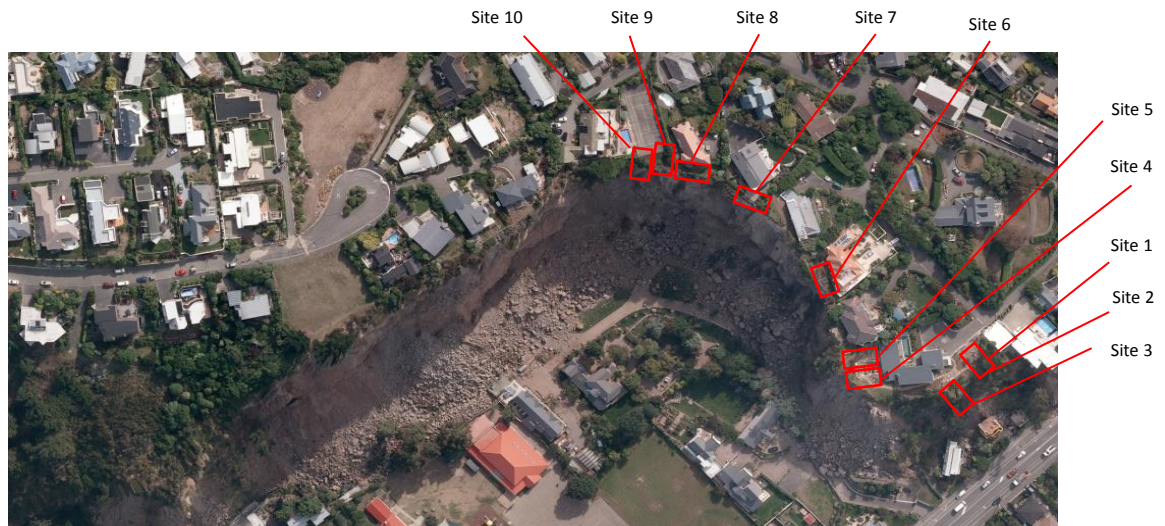
**Figure 36 - Aerial photograph displaying the locations of the 11 fractures identified, but only 10 were monitored between April and early June 2011.**

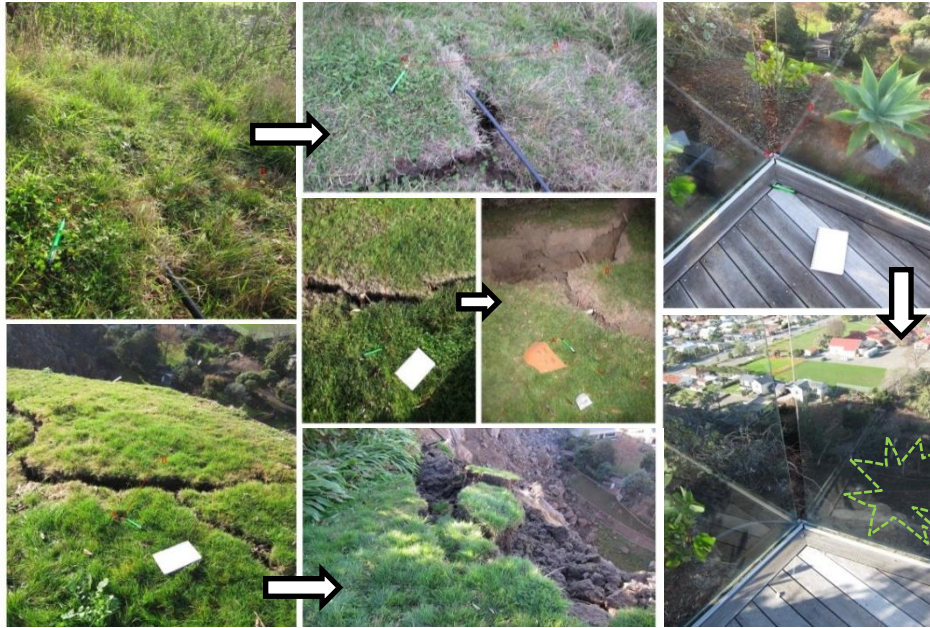
Figure 37 - A collage of photographs taken at showing examples of some of the fissures formed as a result of the February earthquake and the variation of responses to the 13 June 2011 earthquake. The rest of photographs documenting the changes to the cliff edge fissures can be found in Appendix II.

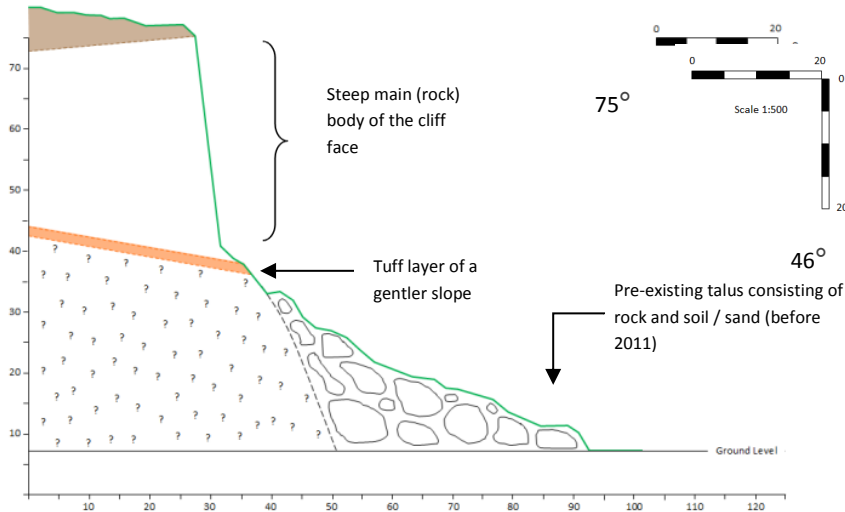
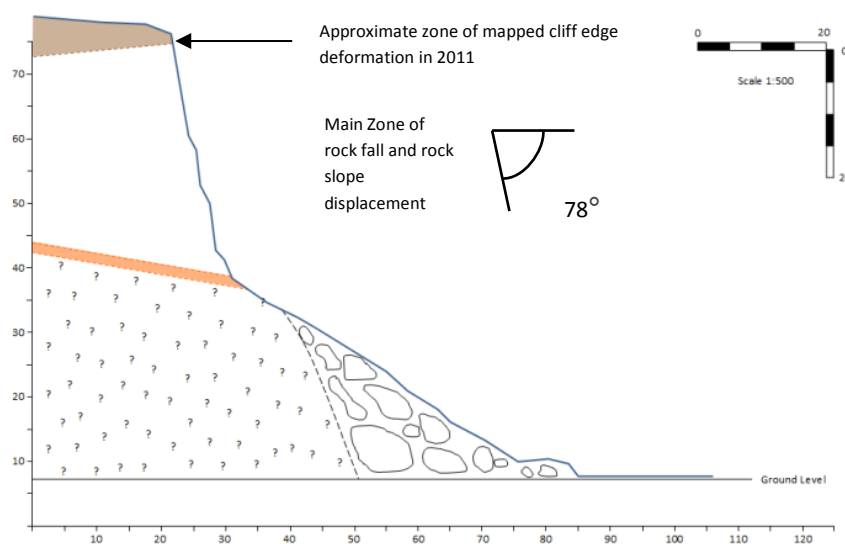
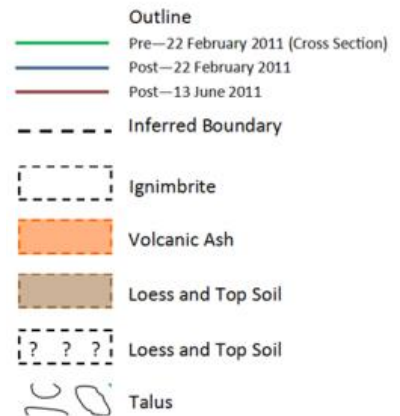
Cross Section Face 6.3

Figure 42 - an example of a section of the cliff face evolving over the course of the two major earthquakes

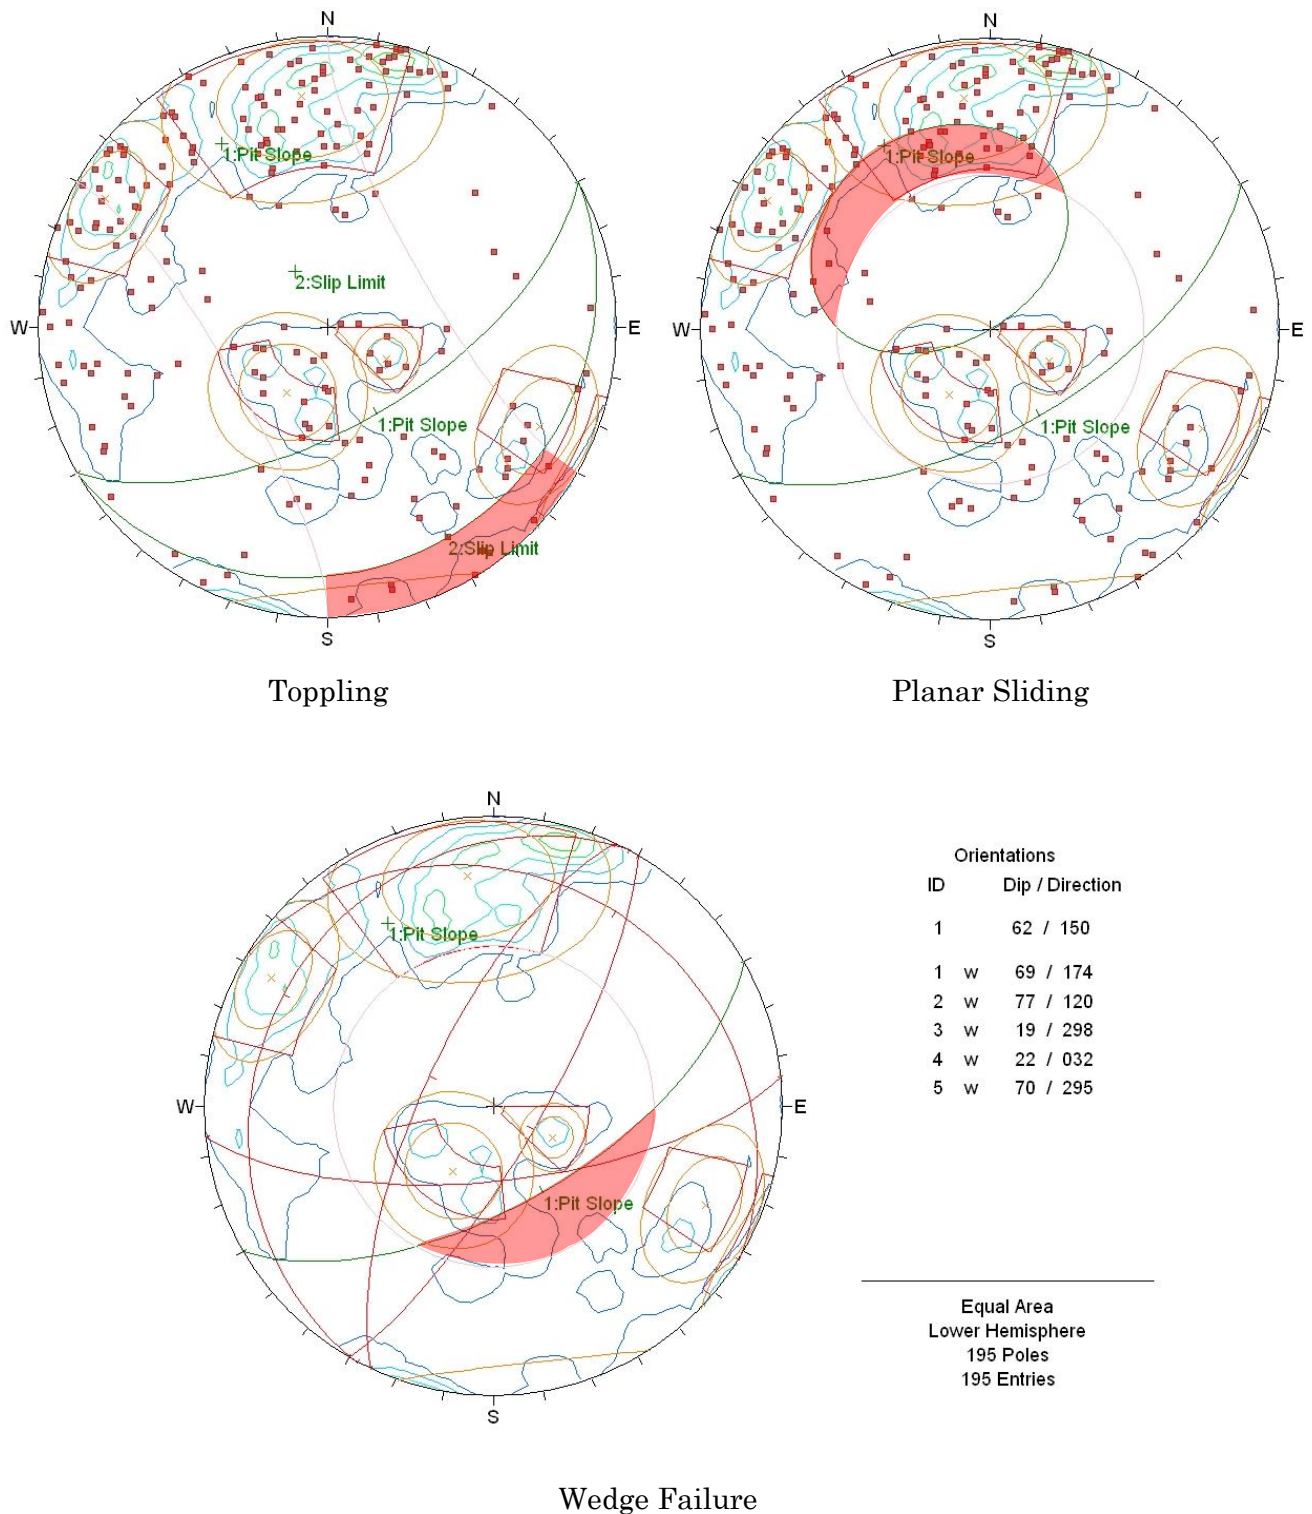
Figure 53 - Results of the kinematic analysis in determining the potential for toppling, planar sliding and wedge failure for the SE-facing cliff face. The area highlighted in red represents the zone of failure for the respective types of failure. This result is applicable to the SE face before and after each earthquake since the overall slope angle remained nearly the same throughout.

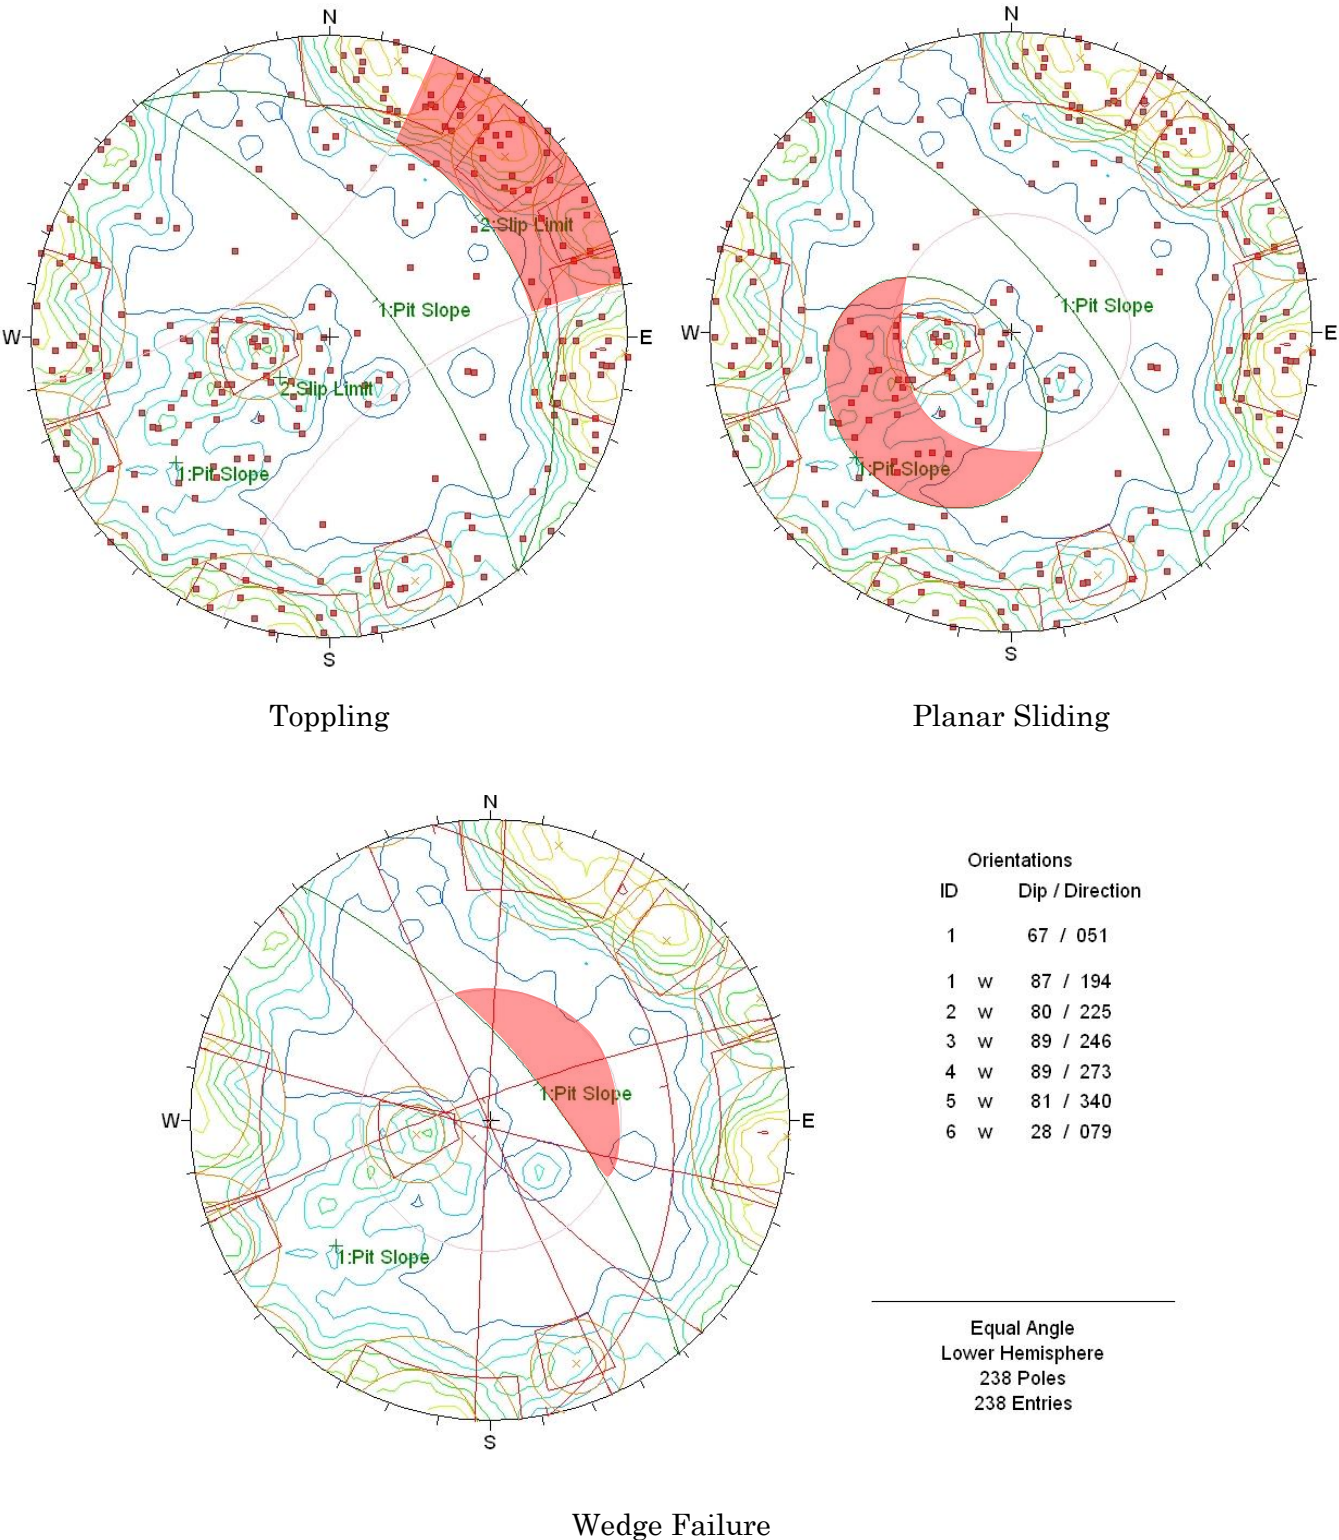
Figure 54 – Results of the kinematic analysis for the NE Face post-February 2011. The area highlighted in red represents the zone of failure for the respective types of failure.

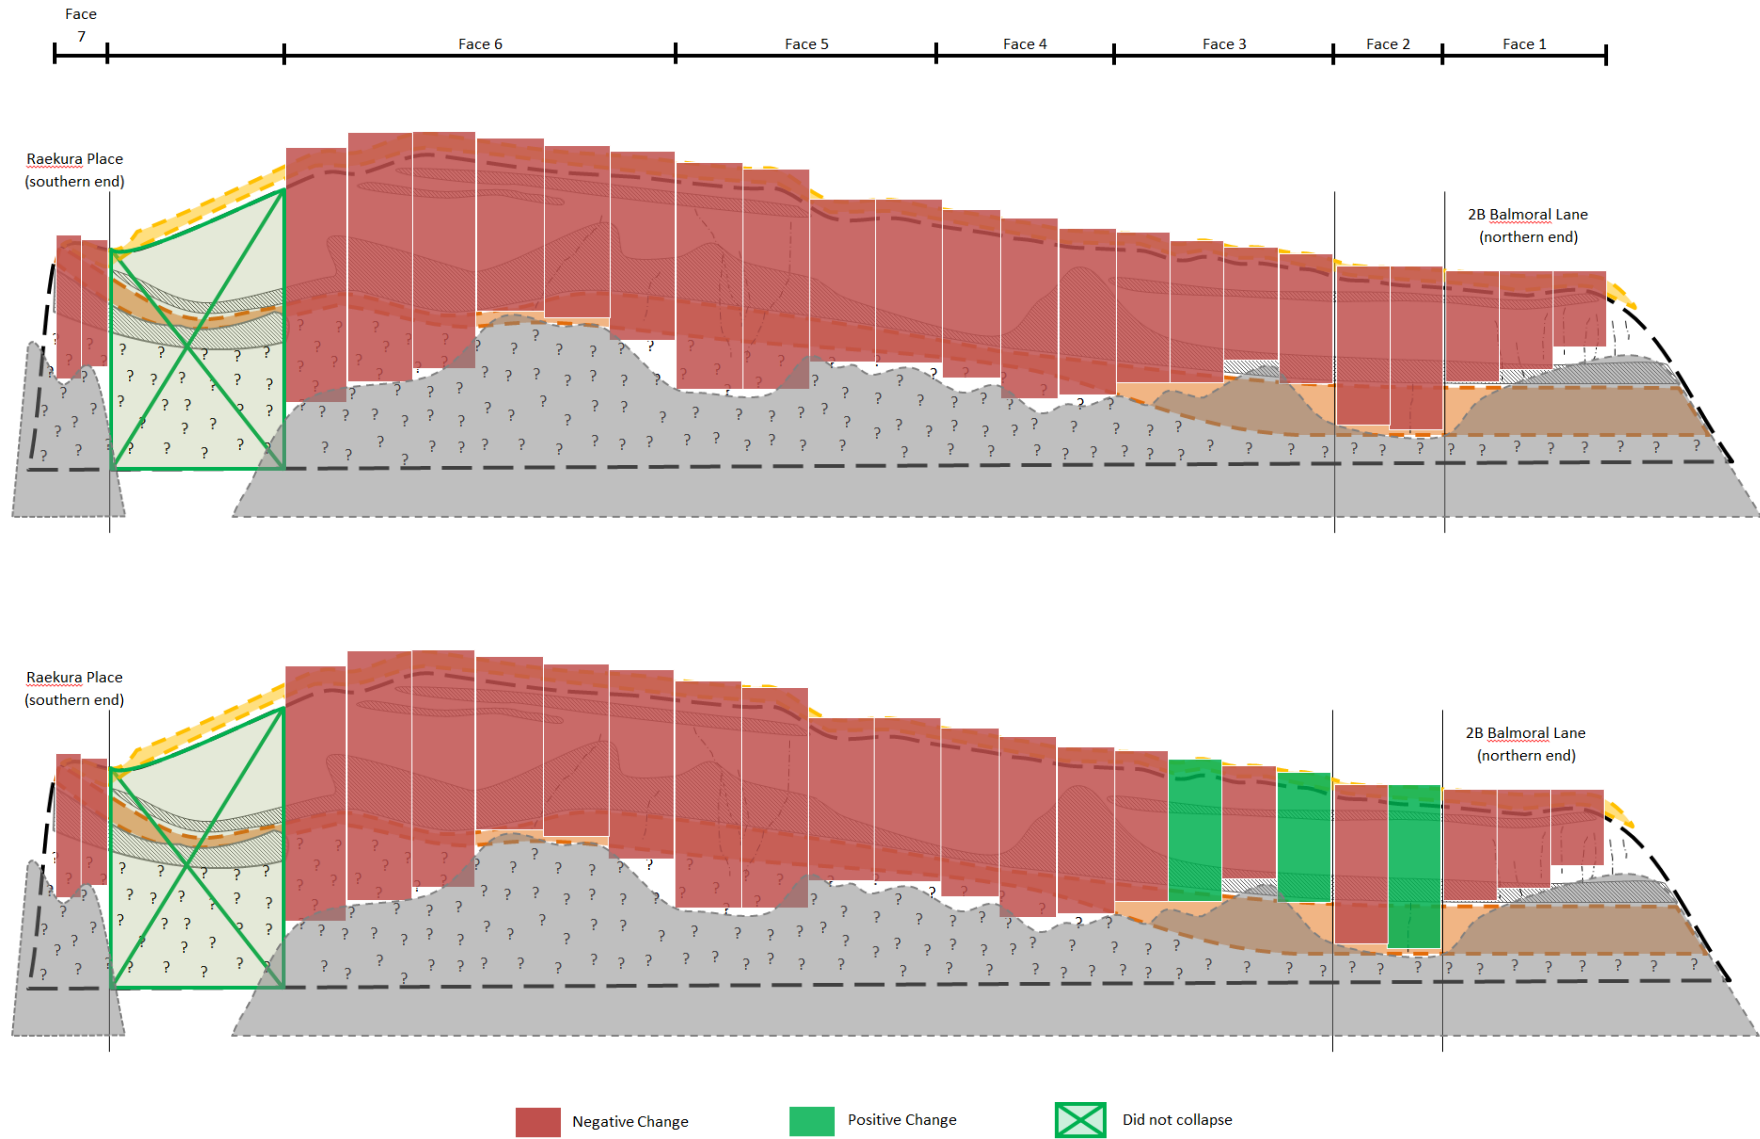
Figure 58 – The resulting positive and negative change models for the collapse of Redcliffs' cliff in A) 22 February 2011; B) 13 June 2011 earthquakes

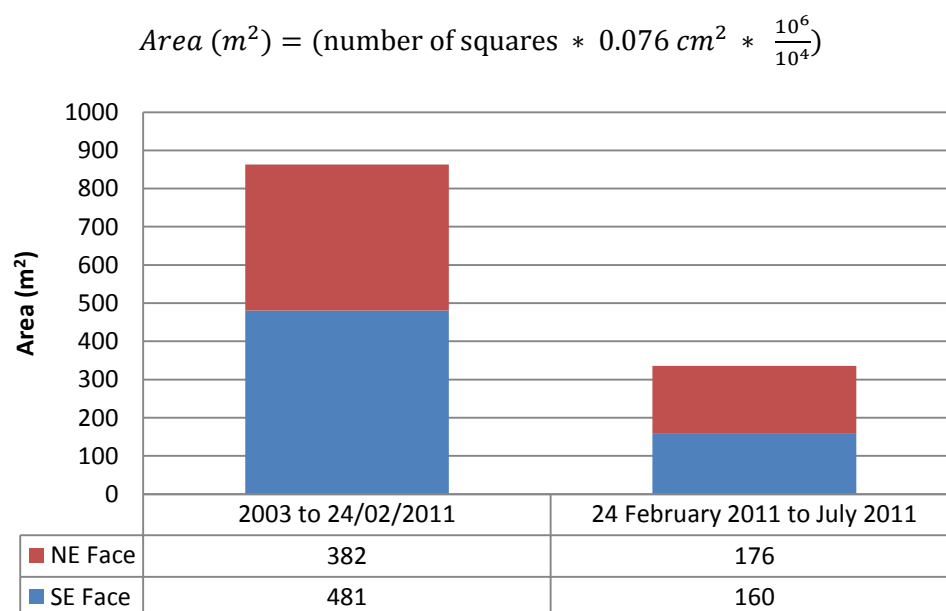
Figure 64 - Estimates are the cliff top (NE and SE Face) lost after each failure incident.
